Audi, Seat, Skoda, Volkswagen. Various models.
1.6 & 2.0 TDi engines

Water Pump

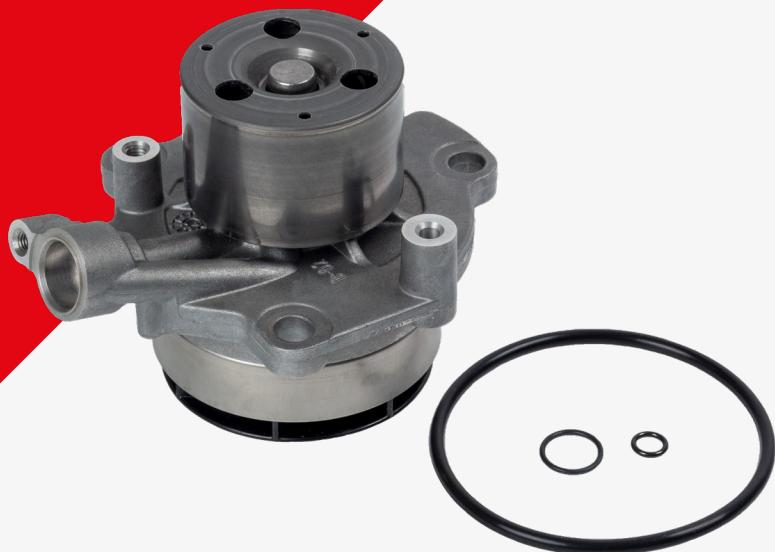
Engine overheating, coolant temperature gauge reading over 110° C and poor interior heater performance. Also cooling system fault codes maybe logged in the engine control unit.

The water pump fitted to these vehicles has an ECU controlled collar, which interrupts the coolant flow to make the engine more thermally efficient. However, the control collar can become seized, or the plastic impeller can break up or come away from the shaft.

Ensure the engine is cool, then remove the coolant filler cap. Remove the small pipe to the coolant header tank and hold this over the filler neck of the header tank, there should be a small trickle of coolant flowing with the engine at idle. This should increase in flow when the engine speed is increased. If the flow rate does not increase, this would suggest a faulty water pump.

Replace the defective water pump with febi replacement part 180948.

The solenoid valve must be removed from the old original pump and fitted to the new pump, including new seals, which are provided in the kit.

Fill the cooling system with the correct coolant, then vacuum bleed the cooling system. Finally carry out the cooling system bleeding procedure, using a suitable serial diagnostic tool, to expel all the air from the cooling system.
